SCREENING SITE INSPECTION REPORT

LAKE ABRAMS HOLDING PONDS

MIDDLEBURG HEIGHTS, OHIO

JUNE 26, 1991

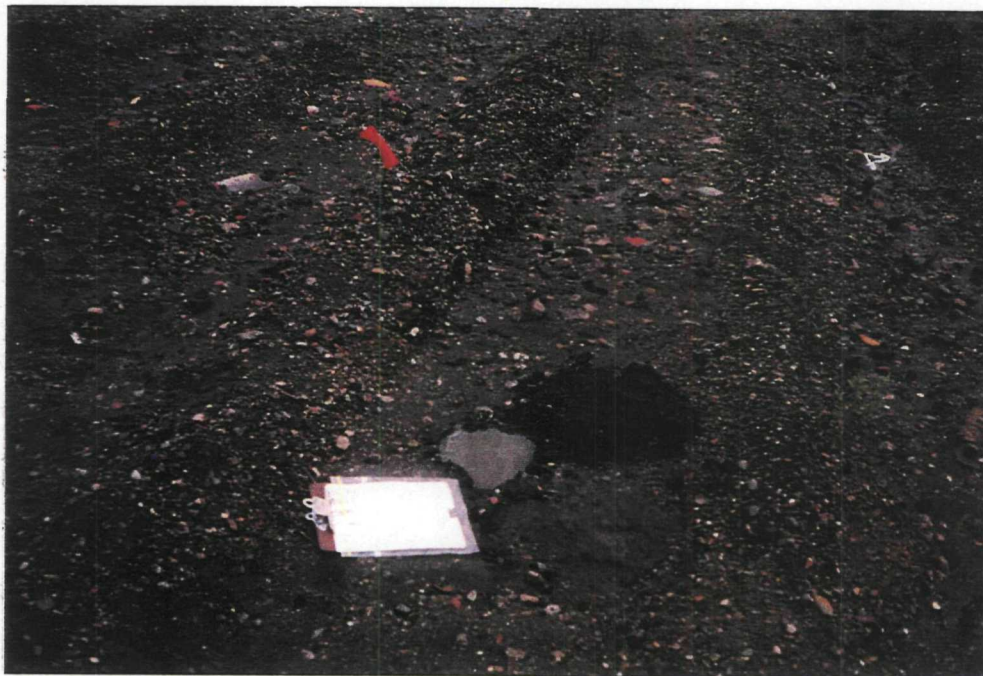
SITE NAME: Lake Abrams Holding PondsPAGE 1 OF 19U.S. EPA ID: OHD980510218 TDD: FO5-8912-013 PAN: FOH0138SBDATE: 10/18/90TIME: 9:50DIRECTION OF  
PHOTOGRAPH:NEWEATHER  
CONDITIONS:Mostly Sunny,light wind ~70°F

DESCRIPTION: SI Close-upDATE: 10/18/90TIME: 9:50DIRECTION OF  
PHOTOGRAPH:NEWEATHER  
CONDITIONS:Mostly Sunnylight wind ~70°F

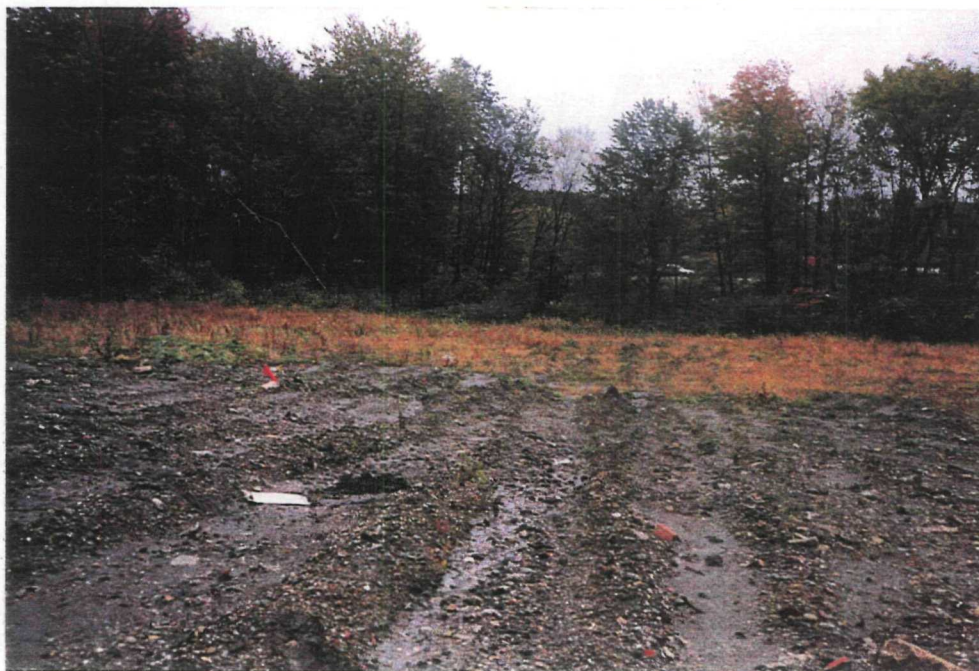
SI Perspective I-71 is located just beyond the  
trees in the background.

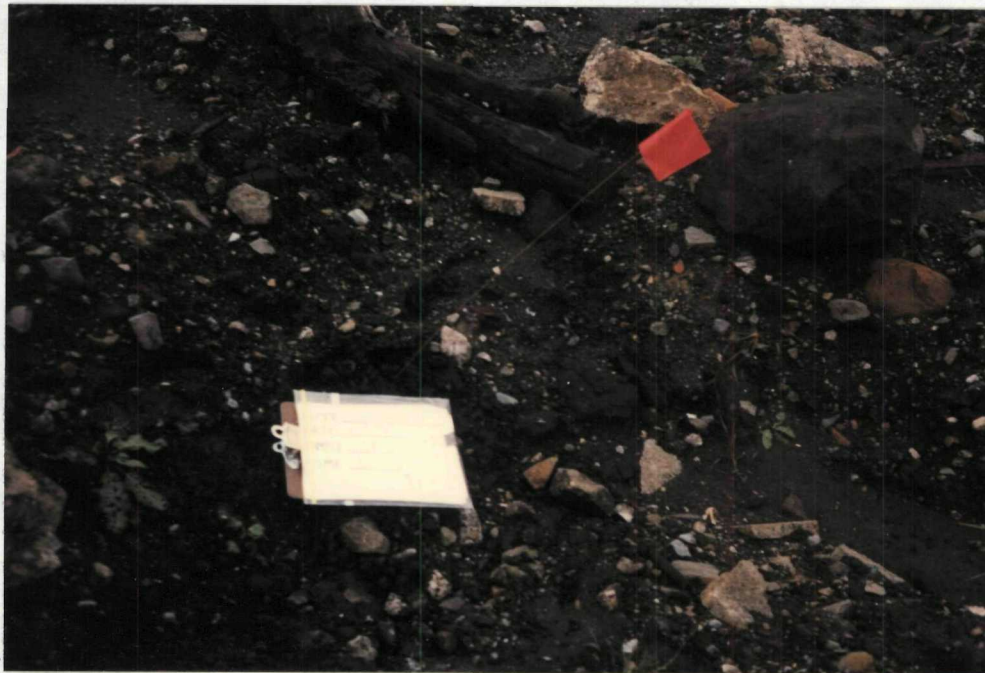
S3 Close-upDATE: 10/18/90TIME: 10:20DIRECTION OF  
PHOTOGRAPH:WestWEATHER  
CONDITIONS:Mostly Sunnylight wind ~70°F

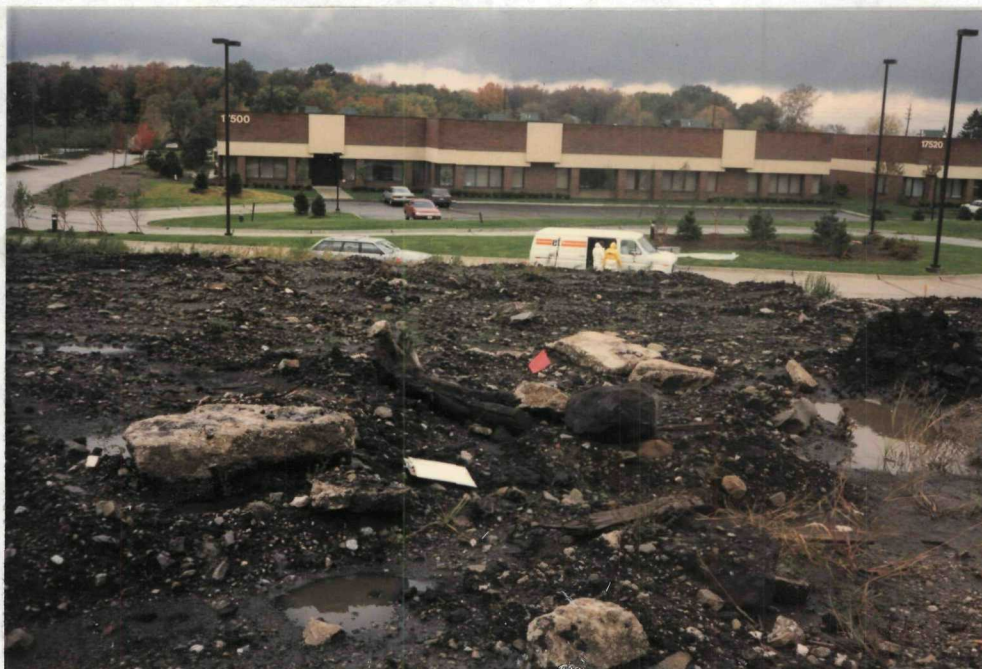
FIT observed chunks of concrete and other construction debris scattered over an approximately 2-acre area east of Engle Lake Drive and extending from near the northern site boundary to just before Lake Engle. FIT also observed an area along the eastern side of the site that appeared to have been recently graded. This area was located approximately 75 feet west of Interstate 71 and appeared to be approximately 500 feet long by 100 feet wide.

S3 Perspective - Lake Engle Drive in the background  
Concrete rubble and construction debris scattered around.

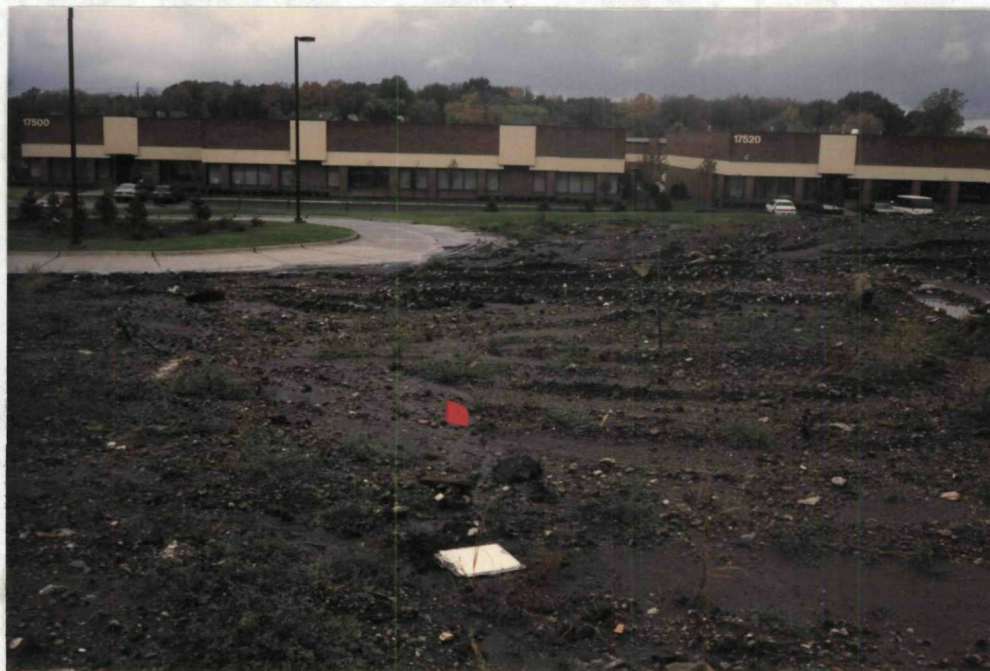
S4 PerspectiveOne-story office buildings and the  
end of Lake Engle Drive in the background.

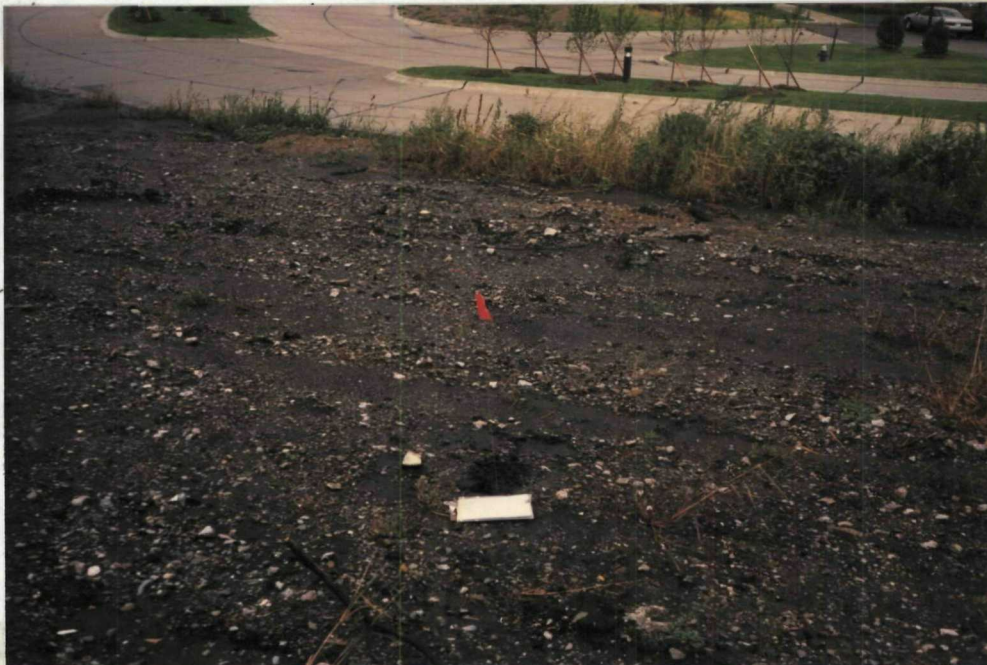
S7 Perspective Lake Engle is located to the left out of this picture. The outflow drainage ditch is located along the left side of the turn of Engle Lake Drive, just beyond the upper left corner of this picture.

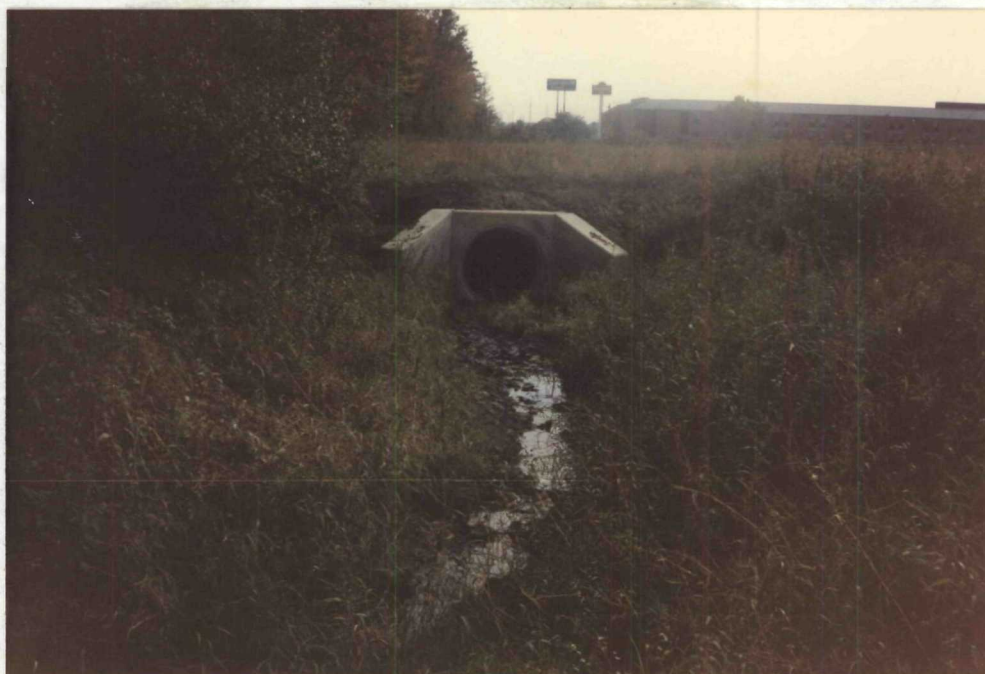
DESCRIPTION: Run-off ditch that runs along the west side  
of I-71. FIT believes that this drain joins with the other  
to release into Lake Engle.

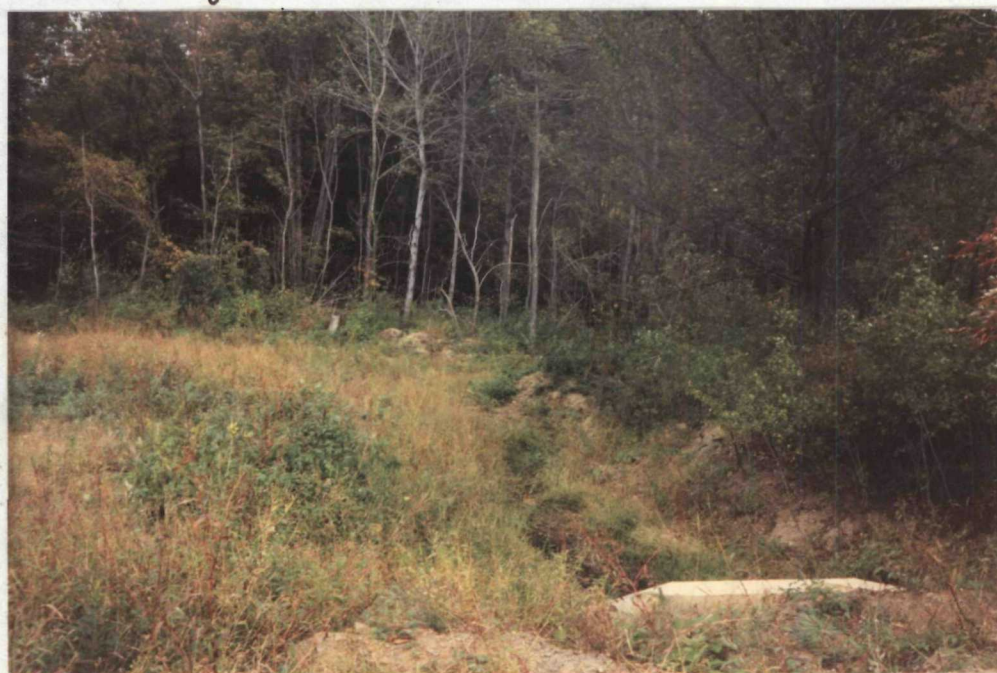
Perspective view of run-off ditch.

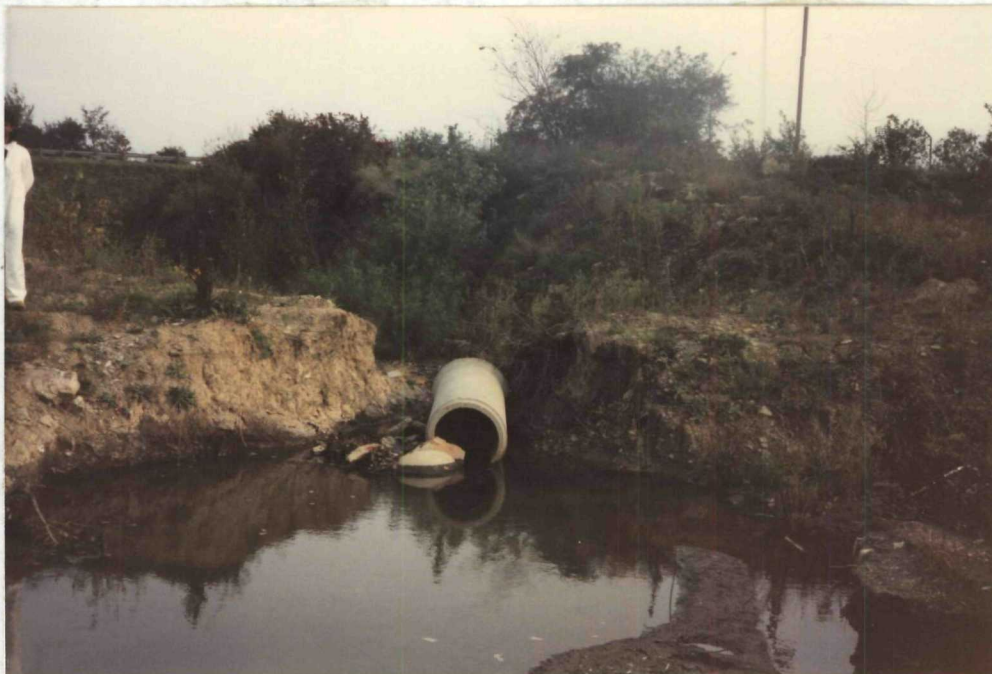
DESCRIPTION: Close-up of inlet to Lake Engle. This drain  
culvert comes from under I-71 (in background) and releases  
run-off rain water into Lake Engle.

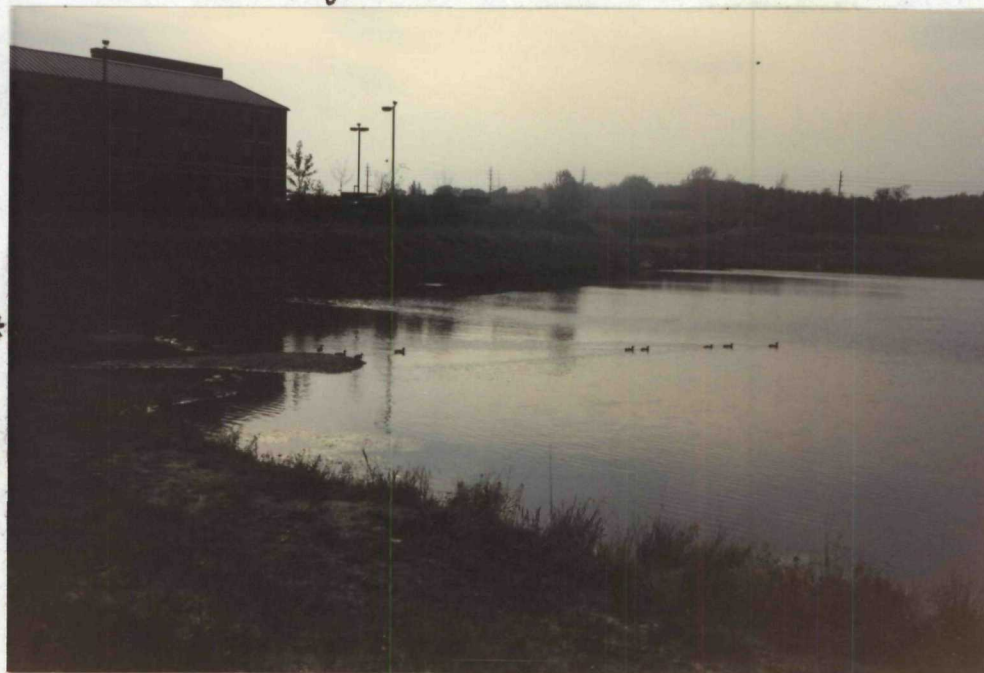
DESCRIPTION: Perspective view of drain inlet.  
\* indicates the location of the inlet.

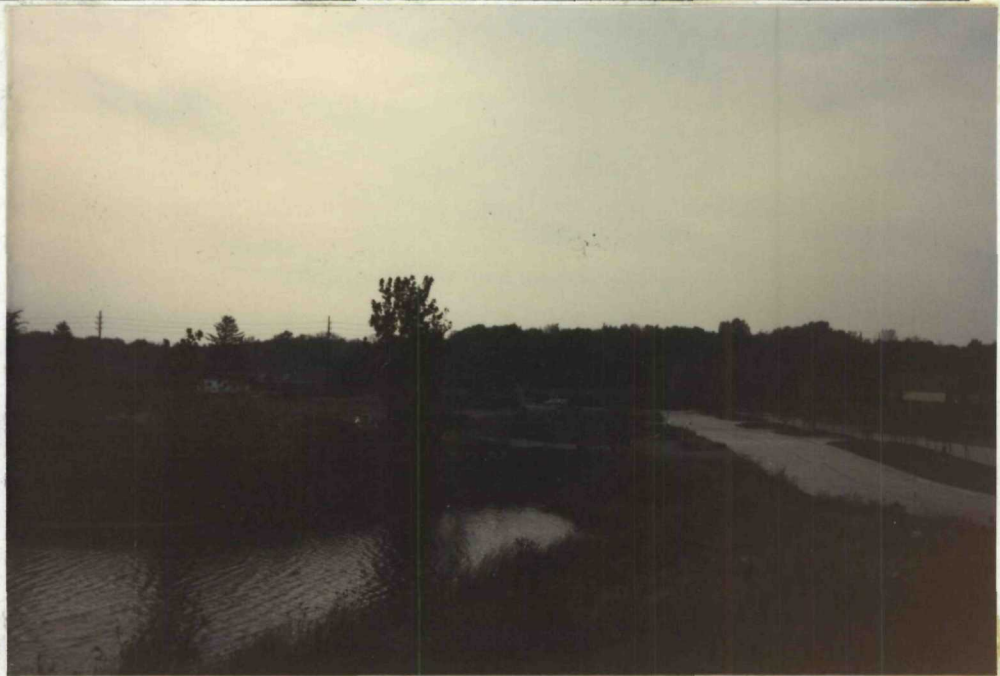
SITE NAME: Lake Abrams Holding PondsPAGE 19 OF 19U.S. EPA ID: OHD980510218TDD: F05-8912-013PAN: FOH0138SBDATE: 10/17/90TIME: 16:10DIRECTION OF  
PHOTOGRAPH:WestWEATHER  
CONDITIONS:Mostly Sunnylight wind ~70°F

DESCRIPTION: Outlet from the Northwest corner of Lake Engle.This flows into a drainage ditch that flows West along Engle Lake Drive. This eventually drains into a wetlands area ~1.2 miles to the west.
